INSTALLATION GUIDE

TCP RCKM-05

Manual Rack & Pinion - Left-Hand Drive

1971-1973 Mustang/Cougar

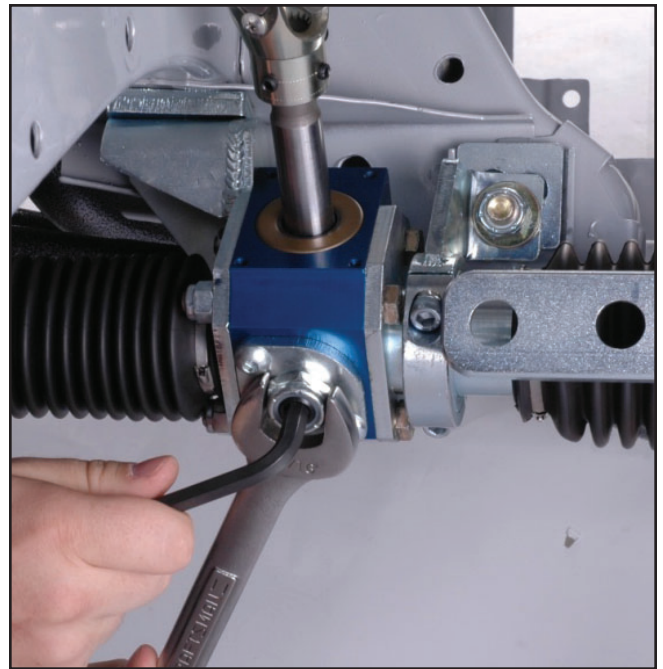
1. Using an even motion, turn the steering wheel from lock-to-lock. The amount of resistance should feel even from one end of the travel range to the other. Any noticeable increase or decrease in tension indicates a possible issue.

- **Notchy feeling or bump every 1/8th turn** – The pinion set screw adjustment at the base of the pinion housing is too tight. Loosen the large lock nut (15/16" hex) surrounding the set screw (5/16" allen) at the bottom of the pinion housing. While lightly rocking the steering wheel back and forth, tighten the set screw until it is seated then loosen 1/4 turn. Hold the set screw in position with an allen wrench and tighten the lock nut. The steering should feel smooth and have 1/16" to 1/8" of play at the steering wheel. Too loose of an adjustment allows excessive play at the steering wheel. Too tight of an adjustment makes steering overly sensitive and can prevent the system from returning to center while driving.

- **Notchy feeling or bump every 1/2 or 1/4 turn** – This usually indicates a binding condition at the intermediate steering shaft u-joints. Verify that the steering shafts do not extend into the open area of u-joint, causing it to bind.

- **Gradual increase in resistance** - The rack tube may be slightly bent due to bracket misalignment. This must be corrected before proceeding.
 - **Light variations in tension** – This is very common and will smooth out once the internal guide bushings have developed wear patterns (approx. 1,000 miles); similar to piston rings seating within a cylinder.
